LITTLE RIVER LOWER DAM  
ME 00288

PHASE I INSPECTION REPORT  
NATIONAL DAM INSPECTION PROGRAM

NOVEMBER 1979

Identification No.: ME00288  
Name of Dam: Little River Lower Dam  
Town: Belfast  
County and State: Waldo, Maine  
Stream: Little River  
Date of Inspection: September 17, 1979

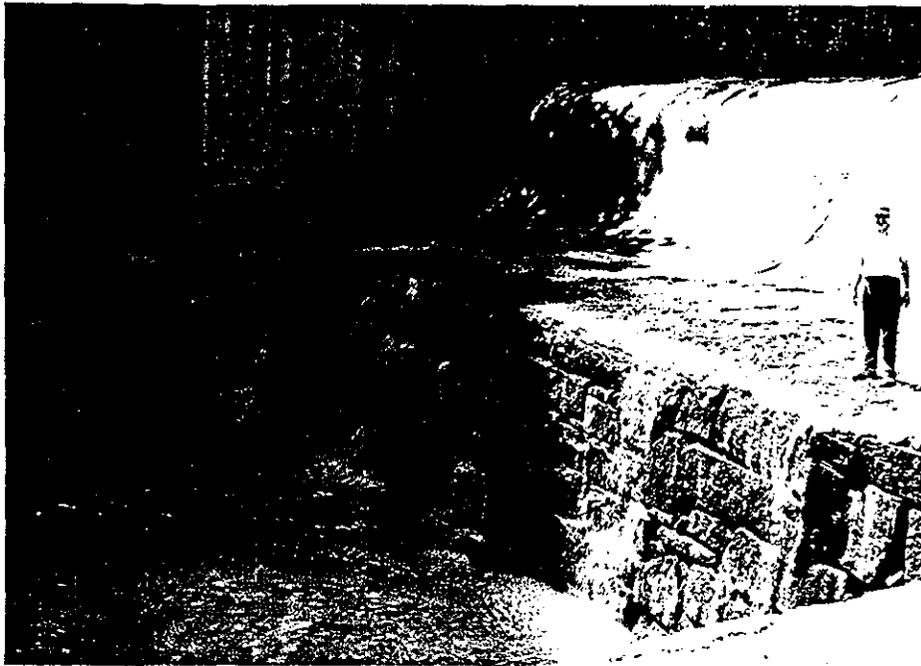
September 17, 1979  
Figure 2. - Downstream face of the dam.

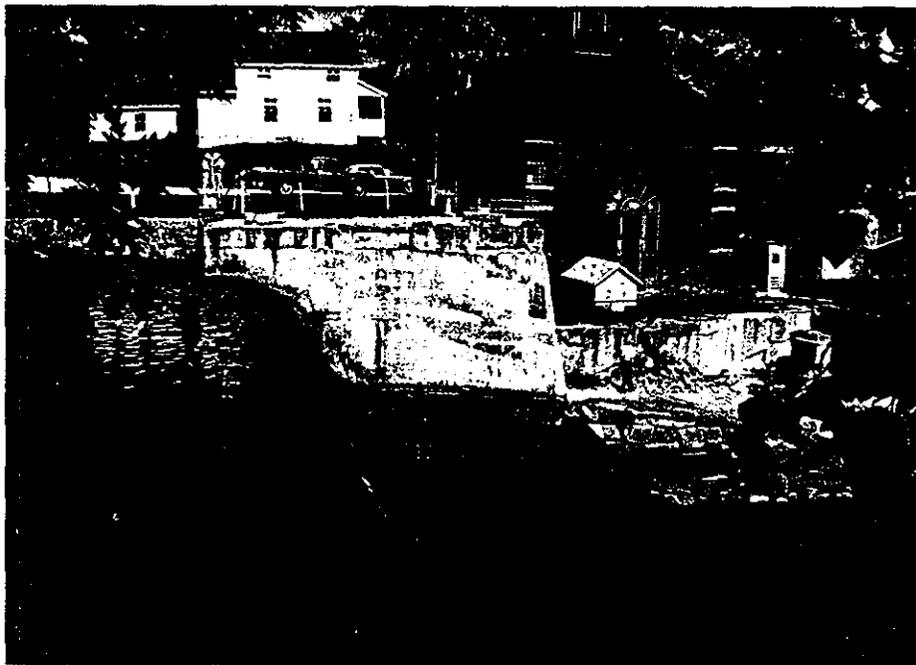
At the north end of the dam there is a massive intake structure which appears to be dry-stone-masonry encased in concrete on the top, upstream face, and river-side face. (See Appendix C - Figures 3 & 4.) The downstream face is dry-stone-masonry. (See sketch plan, Appendix B.)

September 17, 1979  
Figure 3 - Looking across the crest at north  
abutment.

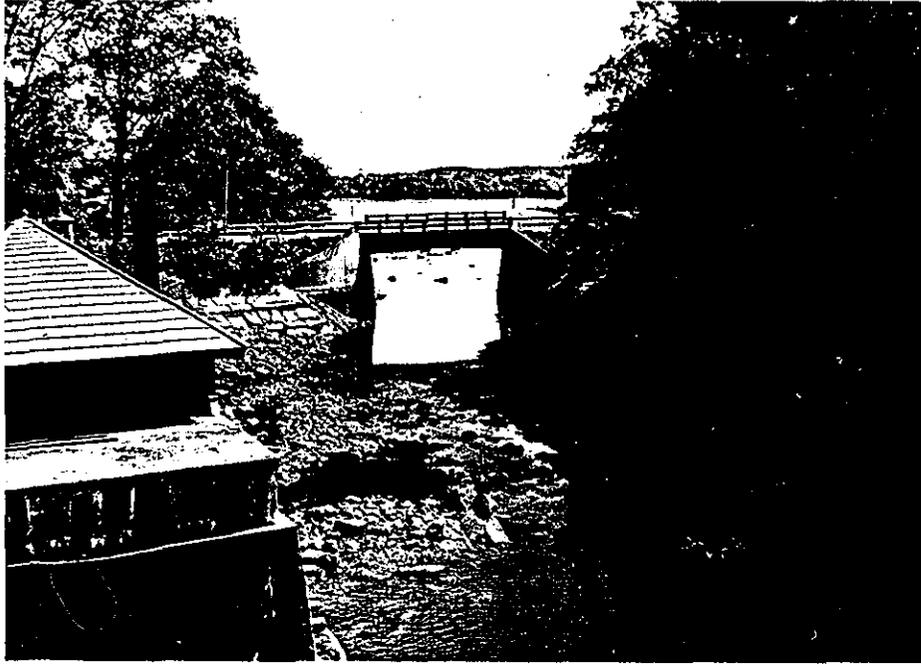
e. Downstream Channel. The downstream channel is bedrock. Trees overhang the south side of the channel. About 400 feet downstream of the dam is the U.S. Route 1 bridge that crosses the channel. (See Appendix C - Figure 12.) Little River discharges into Penobscot Bay through a channel lined with well-placed derrick stone. (See Appendix C - Figure 13.)

September 17, 1979  
Figure 12 - Looking downstream at U.S. Route 1 bridge  
from the north abutment of the dam.

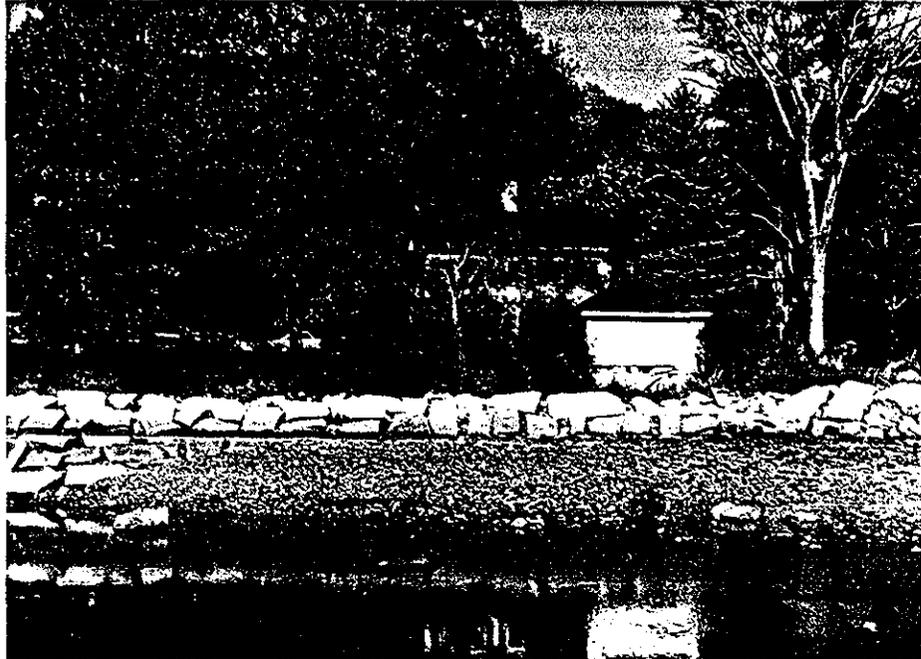
September 17, 1979  
Figure 13 - Looking north at downstream channel below  
the U.S. Route 1 bridge just before  
confluence with the Atlantic Ocean.
